**LA VILLITA RFP – EXHIBIT 9**  
**CATEGORY A - WORKING ARTIST STUDIO GALLERIES**  
**BUILDING INFORMATION**

## BUILDING 1

### **Bowen/Kirchner House, c. 1870**

**GENERAL ASSESSMENT RATING: 4-Good**

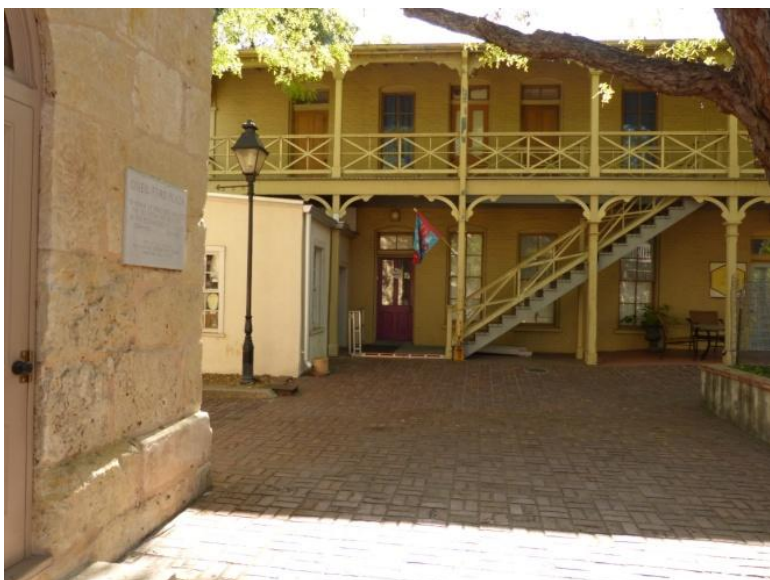
Portable metal ramp for disability access has been installed under rear porch to serve River Art Gallery.

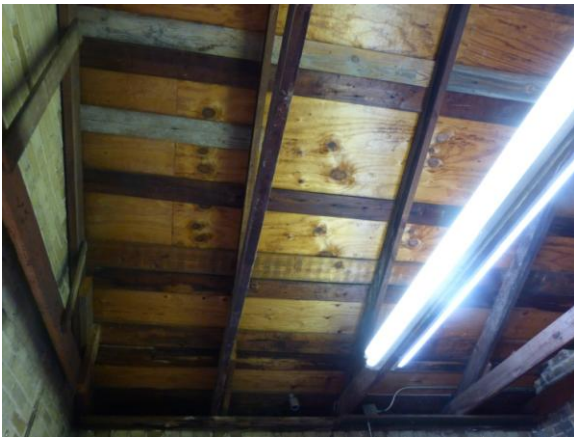
Building 21A—Ceiling

**Ceilings.** Exposed wooden trusses and wooden roof decking.

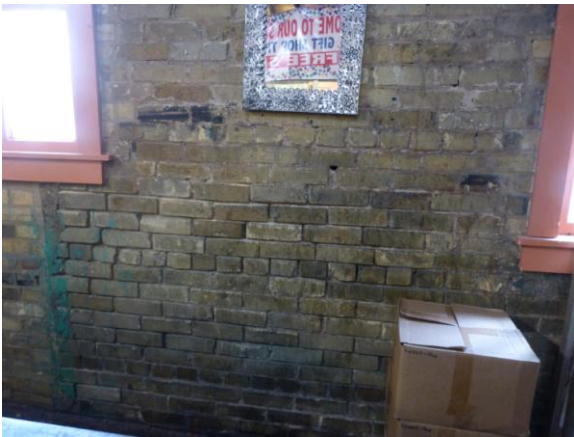
Building 21A—Brick wall

**Walls.** Exposed brick on inside needs to be repointed.

Northeast corner of building has cracked and buckled, probably from ground movement caused by water. Wall needs to be rebuilt from approximately 4 feet above the floor to the roof.

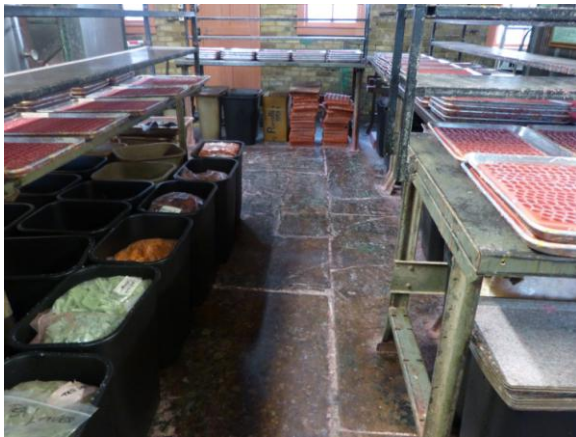
Building 21A—Flooring

**Floors.** Carpet over plywood in east room floor framing may be deteriorated. Concrete in rear of building. Acceptable for current use.

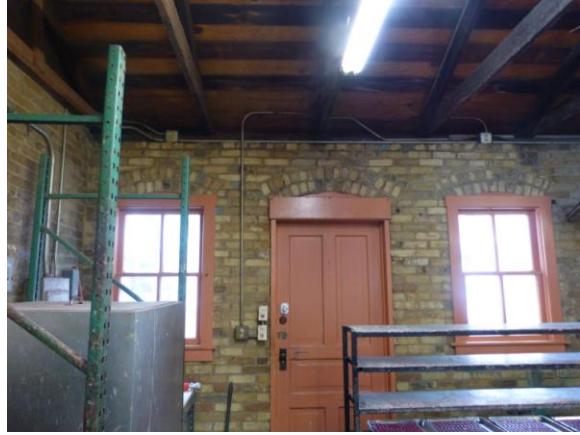
Building 21A—Back door

**Windows and doors.** Most windows require major repairs or replacement. North door and large sliding door at south wall should be replaced.
